# Dunsford

## Conservation Area Character Appraisal

Dartmoor National Park Authority September 2011

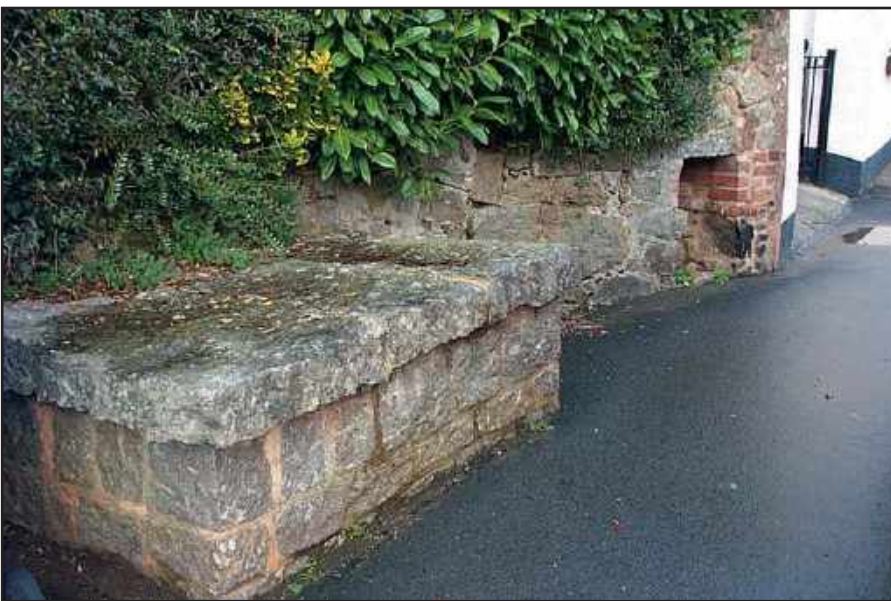
A stream flows south through the centre of the village but is culverted from the north of the school grounds to the south of the main street. The apparently redundant pipe in the wall near the school suggests that until quite recently the stream was simply culverted under the road itself and would have been both seen and heard, like the one next to Foxhole.

*Fig 2: Evidence of water management, old and new*

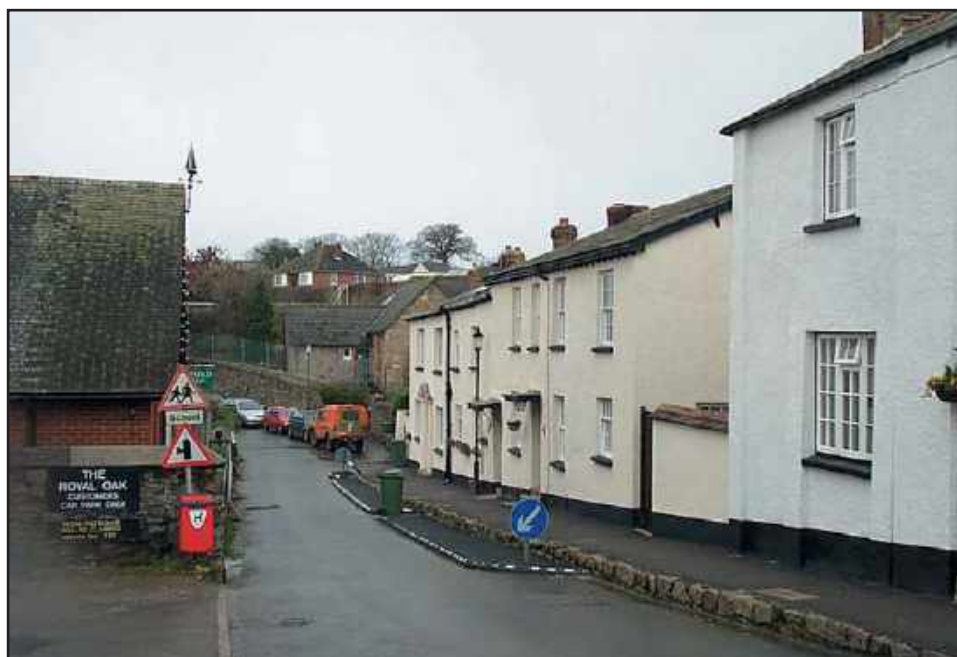
The majority of houses and cottages are located tight to the street frontage with only a small (often cobbled) area between wall and road. The informal terraces and looser groups run parallel to the main street and also a little way down Briton Street Lane and The Court. Lewishill and Townsend are unusual in being set back from the street.

*Fig 3: Building form may have evolved but the sense of continuity and enclosure continues*

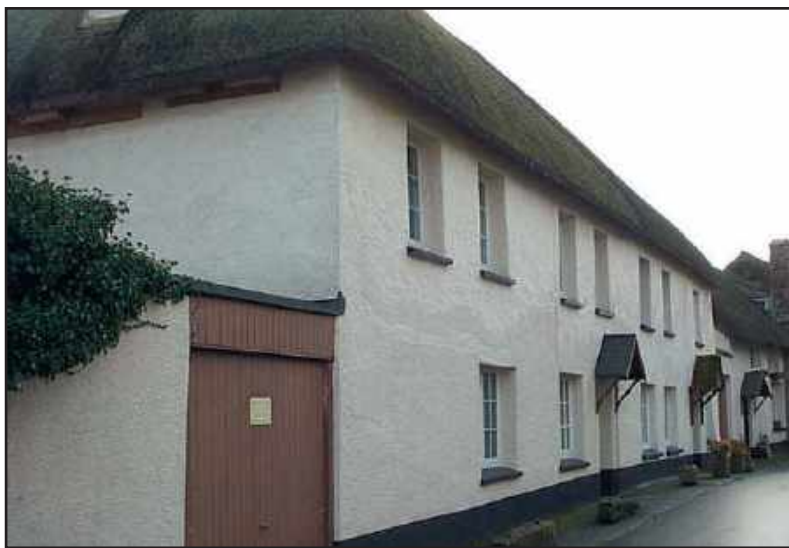
Fig 4: Rendered cob and thatch – the essential character of Dunsford

At its heart Dunsford has a fine collection of cross passage houses in the Devon vernacular tradition. Although many have been altered and extended, the majority of homes have a linear plan, being only one room deep, and run parallel with, and tight to, the street. Their origins range in date from the 15th century (Lewishill) to the 18th century (e.g. East Steps and Foxhole) and all are built of (usually) roughcast rendered cob on stone plinths with thatched roofs. The traditional ridge finish of a wrapover type, either flush or straight block cut is the prevailing character. Until the 19th century every building except the church would have had a thatched roof. After that time slate was introduced, firstly on new build and in the 20th century as a replacement for thatch. The almost ubiquitous use of white or cream on walls reflects the historic limewashed finish and adds to visual harmony.

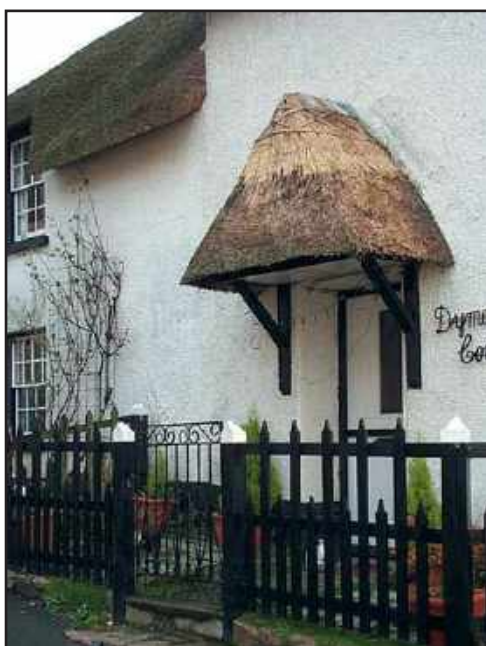
Fig 5: Thatched canopy at Dymond Cottage

Entrance canopies are quite commonplace and clearly have a practical function, especially below thatched roofs, most are slated, some are thatch and a few are leaded. Apart from several quite modern examples porches are not a feature on the historic buildings of Dunsford.

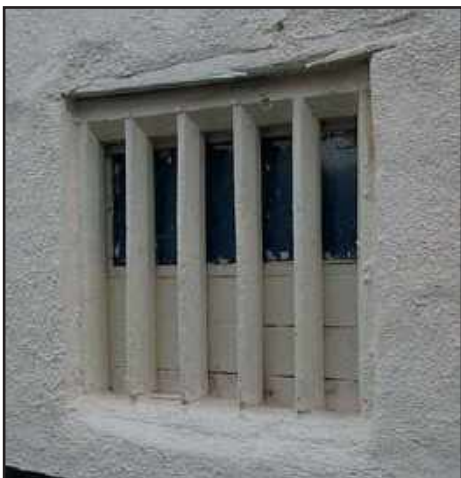
*Fig 6: Mullioned window*

The great majority of windows are casements, though there are not many really old examples left. One exception is a chamfered mullion window in an outbuilding opposite Old School House. Buildings of the 19th century tend to have vertical sliding sashes. The number of properties with inappropriate replacement windows, both in timber as well as PVCu, is increasing. The pattern of subdivision and mode of opening is often altered, with the introduction of quarter-lights or fanlights and the loss of glazing bars especially notable. There is a mix of boarded and panelled doors in the village.

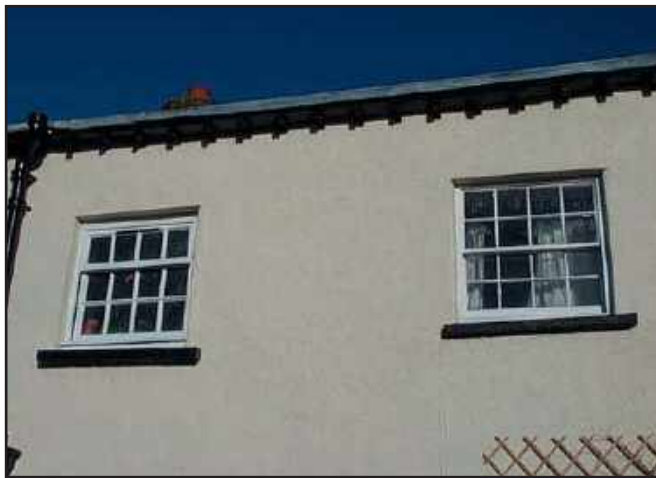
*Fig 7: Even subtle differences can make replacement windows significantly different to original examples*

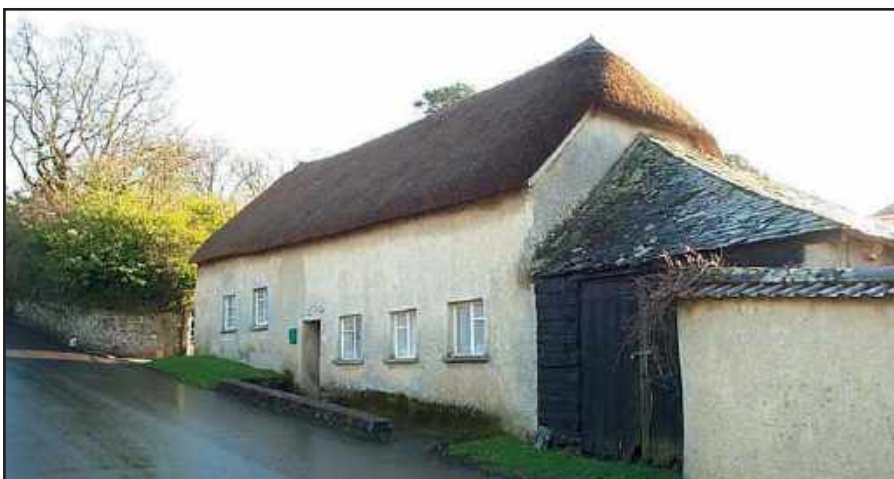
*Fig 8: The Doctor's Surgery – the random slate on the extension is now a rarity*

Historically just about all of the outbuildings in the village would have been of similar vernacular construction with thatched roofs. Only the Doctor's surgery at the eastern end of the Conservation Area retains this character. Other barns have corrugated iron instead of thatch and those that have been converted from residential use have slate.

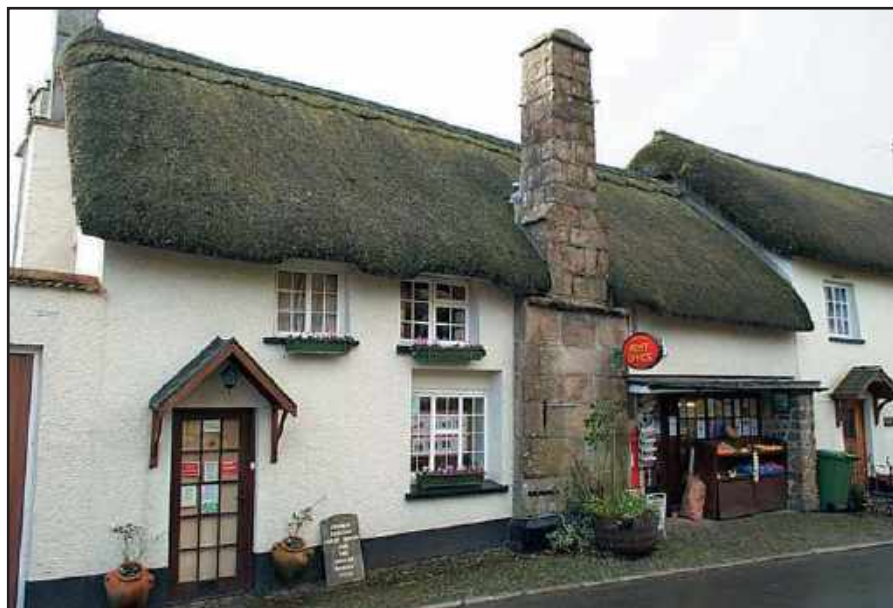
Fig 11: The Post Office with its fine lateral chimney stack

The low eaves and prominent lateral stack reveal the 16th century origins of this building. It is the focal point of the important group opposite the churchyard and as the village Post Office it is also at the heart of the community.

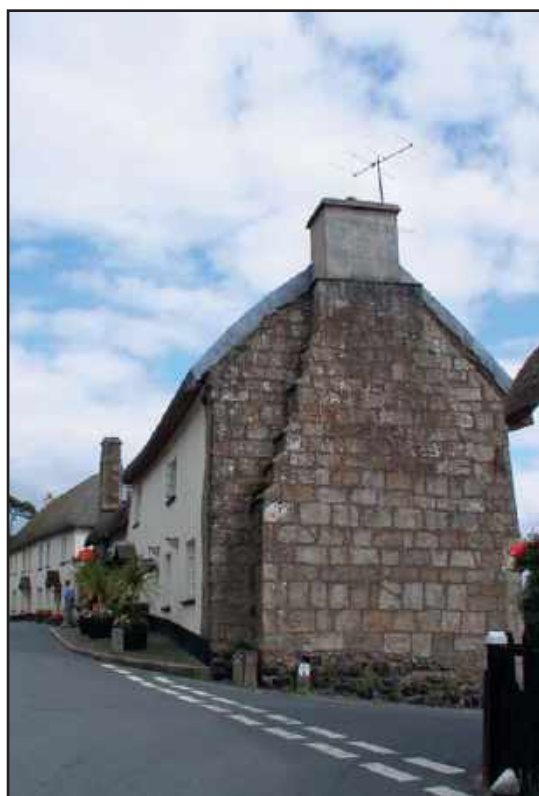
Fig 12: The Old Post Office with its massive gable chimney

Believed to have been built in the 17th century as the service range of Chubbs Farm. The massive stepped gable chimney is one of the distinctive character features that distinguish Dunsford. It has a prominent location on the important central junction.

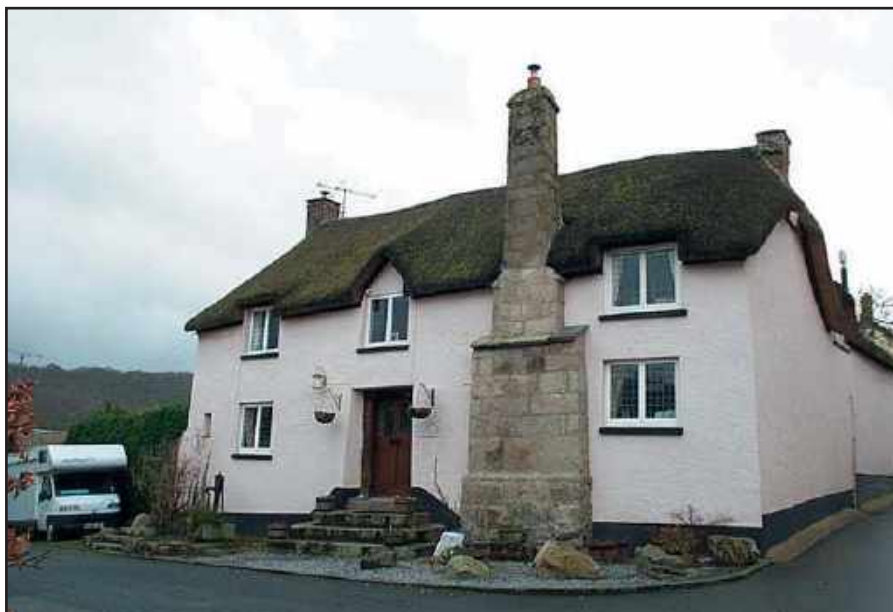
Fig 13: Old Cawte Farmhouse

Dating from the 16th century, this building has the third exceptional chimney stack in the village. Its plan has evolved through a number of phases which have mostly added to its special character. The farmhouse is unusual in that it does not front the main street but instead faces its own little side street.

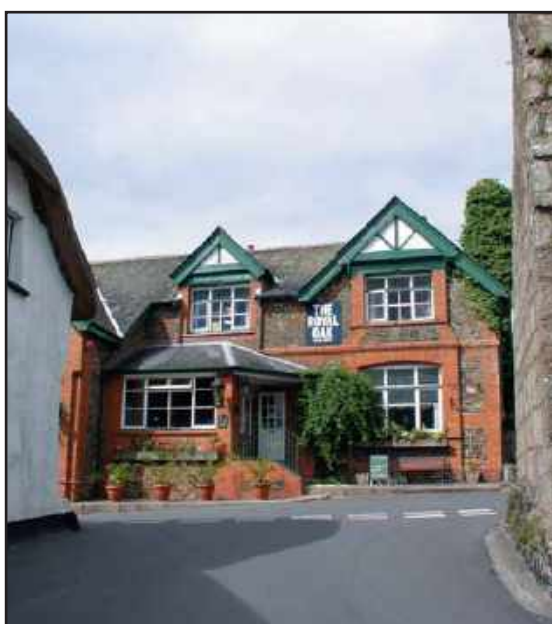
Fig 14: The busy elevation of The Royal Oak is unique in Dunsford

By virtue of its position on a kink in the main street next to the church and closing the view at the top of Briton Street Lane, this is a key building. The complexity of plan and elevation create interest in views from all angles. Although its exposed local stone with brick dressings is a unique combination in Dunsford, it is a memorable and distinctive part of the village. As the local inn it is also an integral part of the community.

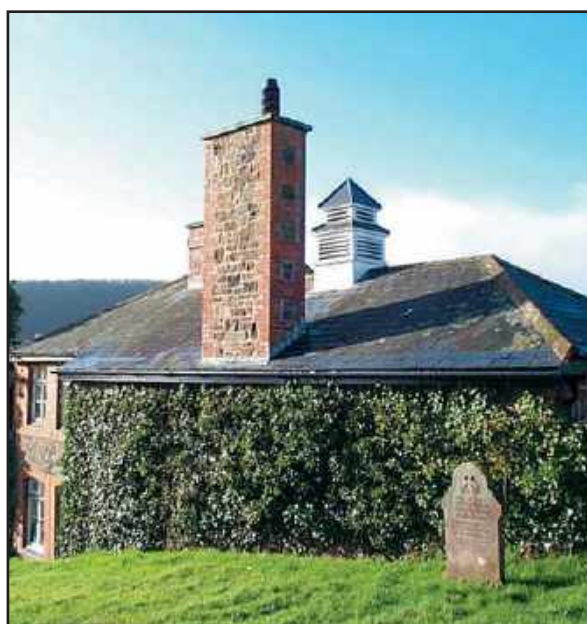
Fig 15: The vented roof is a strong feature from the churchyard and in more distant views

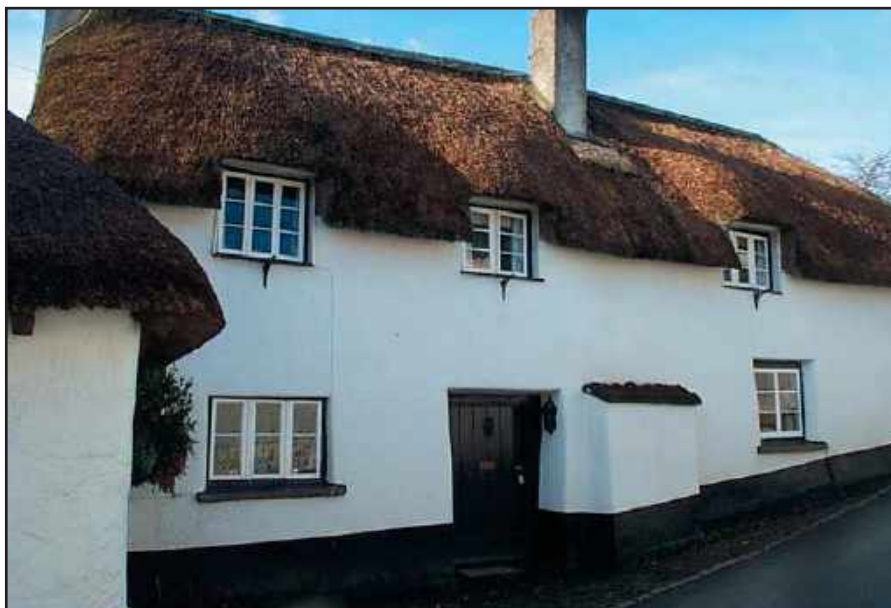
Fig 16: Brimblecombes

This group epitomises the architectural character of the settlement. The dwelling itself has 16th century origins as an open hall house with later alterations. The 18th century adjoining barn sits neatly alongside Brimblecombes to the south, and to the north is the wall that retains a thatched cap and is the last of the tall walls in Dunsford to do so.

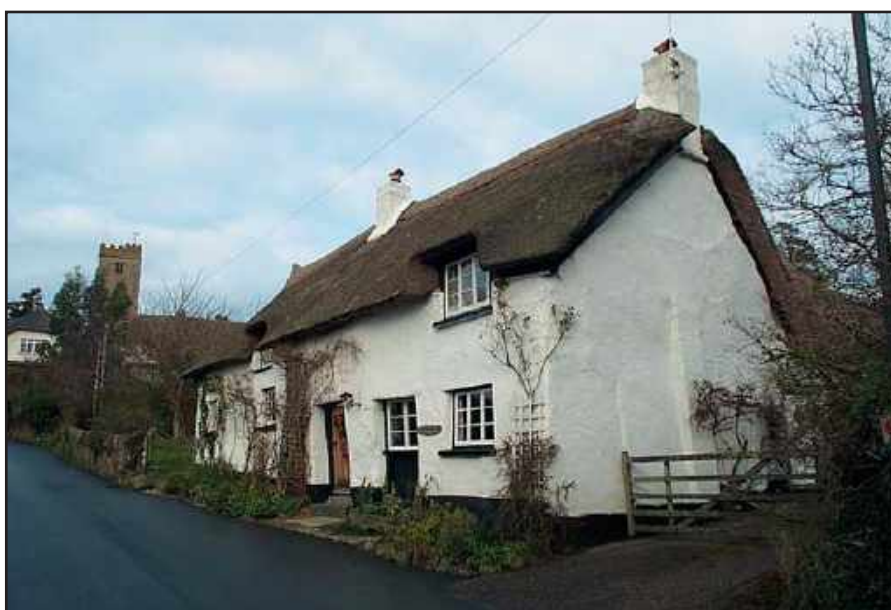
Fig 17: Doone Cottage is presently outside the Conservation Area

A delightful 17th century house, typical 3-room cross passage plan and vernacular construction. Like many such properties it was subdivided in the 19th century but is now one home again. Presently outside the Conservation Area but it is a focal point entering and leaving the village along Briton Street Lane.

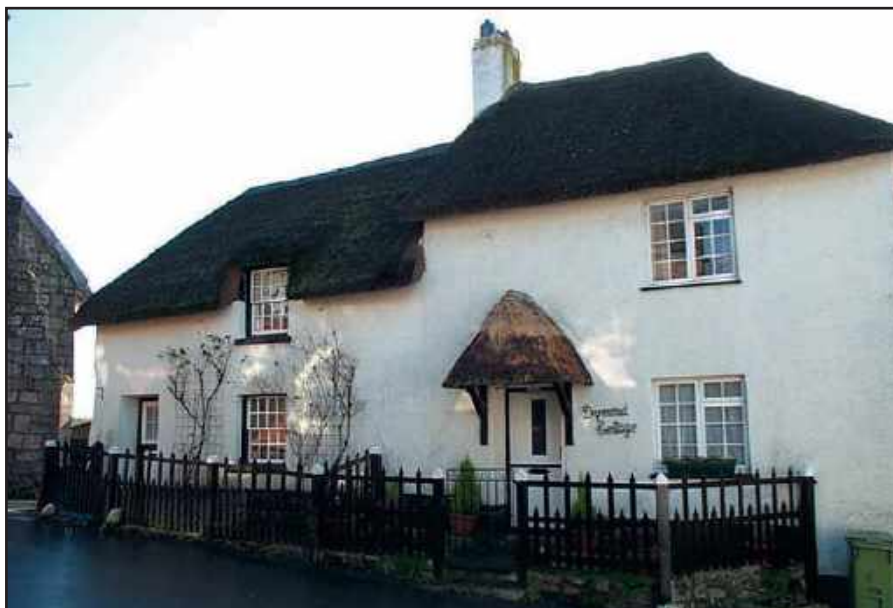
*Fig 18: The unusual picket fence and continuity of materials keep the visual unity of the pair*

The quirky change in height between the two properties adds interest in the roofscape, especially when viewed from the churchyard. This pair of cottages is part of the distinctive group in the centre of Dunsford and an essential element of the village character.

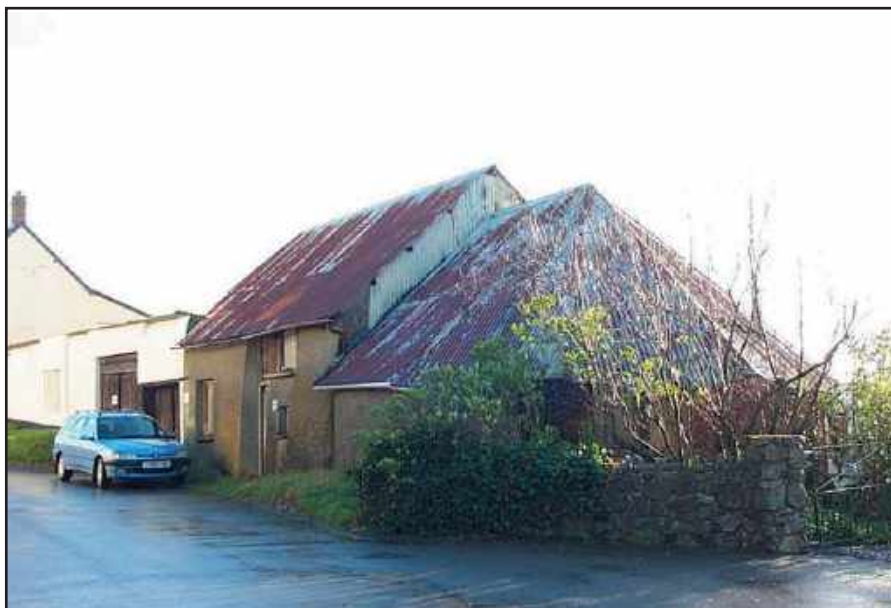
*Fig 20: The thatch on this old barn was replaced with corrugated iron a long time ago*

A rambling cob building, formerly thatched but now with corrugated iron. Appears to be a small threshing barn with a horse engine house on the gable end – a rare position if that was its purpose. As the most prominently located unconverted agricultural building in the village it is in need of sympathetic restoration and use.

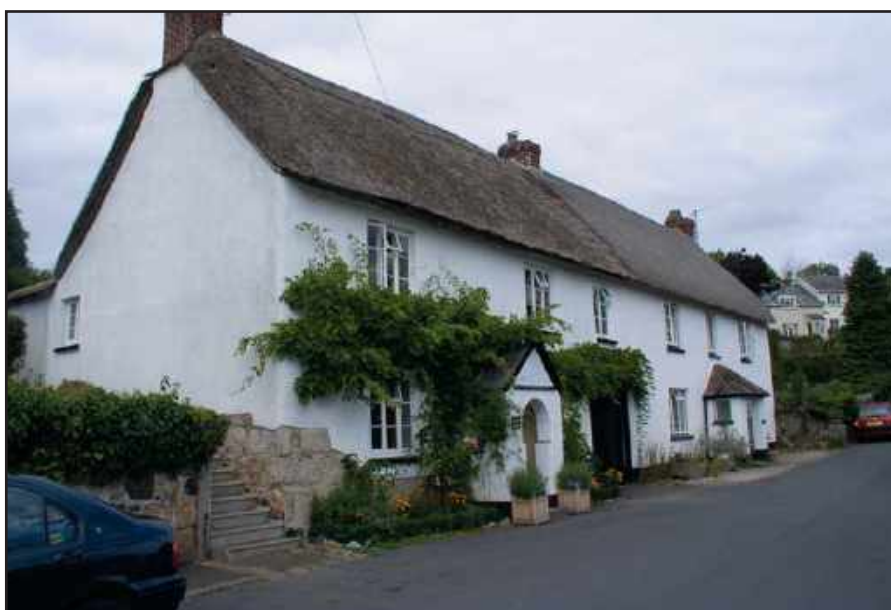
*Fig 21: East Steps and Foxhole*

Probably the last thatched homes to be built in Dunsford around the early 1800s. The taller stature, deeper plan and regular fenestration are indicative of their age. Sited at the bottom of Reedy Hill adjacent to the church the pair make a significant contribution to the quality of the village centre.

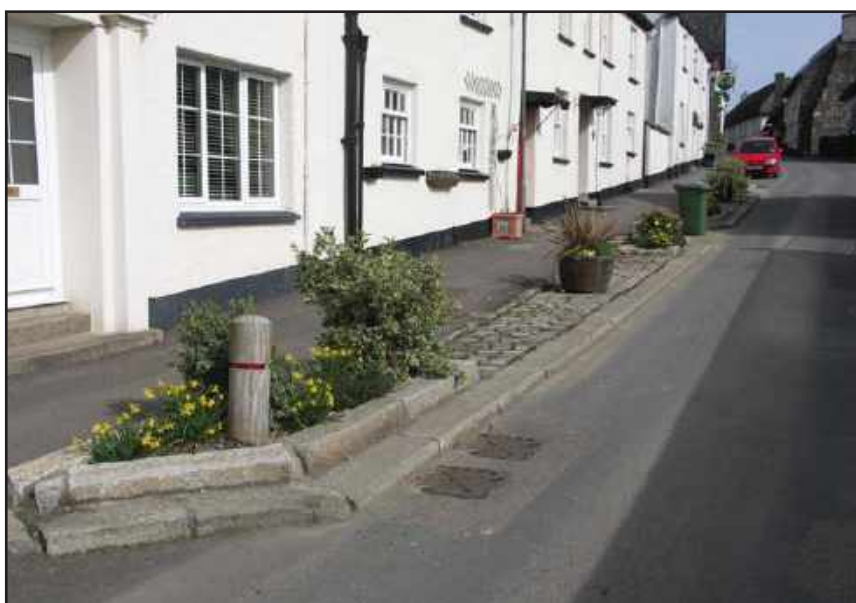
Fig 23: Traffic calming on the main street

Although involving a small increase in the number of traffic signs, the traffic calming measures recently carried out in the highway were done in a most sympathetic manner using granite kerbstones and setts and relying mainly on planted beds and planters (rather than numerous bollards) to deter over-riding by vehicles [Fig 23 below and Fig 29 page 26].

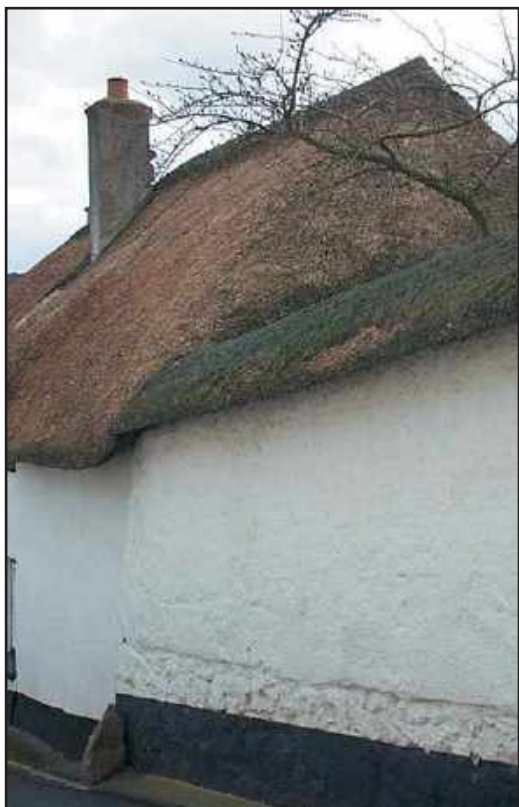
*Fig 24: The wall between Dymonds and Brimblecombes is the finest example of traditional enclosure in Dunsford*

There are two kinds of walls that abound – tall walls in rendered cob with a variety of cappings but all originally thatched, and stone walls in granite or assorted rubble stone. The cob walls are a particularly typical element of the streetscape in Dunsford and some fine examples are found enclosing gardens as well. These have lost their render in some cases but the scale of the walls and the sense of enclosure they offer to the streetscene throughout the village is distinctive. The walls that frame the top end of Briton Street Lane epitomise the character of cob boundary walls.

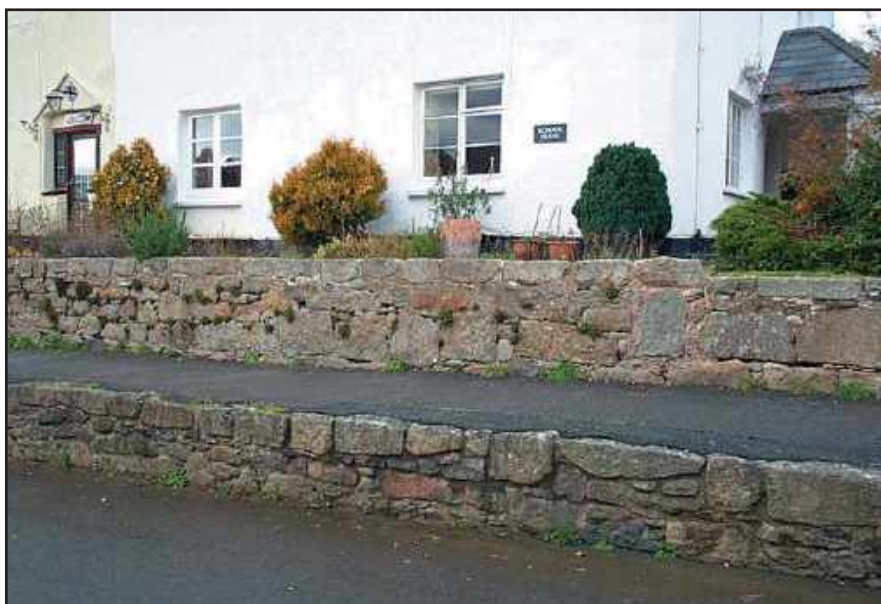
*Fig 26: Raised pavement and garden wall at Old School House*

The stone walls vary considerably, from rough rubble to dressed granite. As well as the prominent examples at the churchyard and Lewishill, there are other interesting walls like the garden wall north of Doone Cottage and the wall at Old School Cottage. The revetment walls that support the raised pavements are another theme of the village.

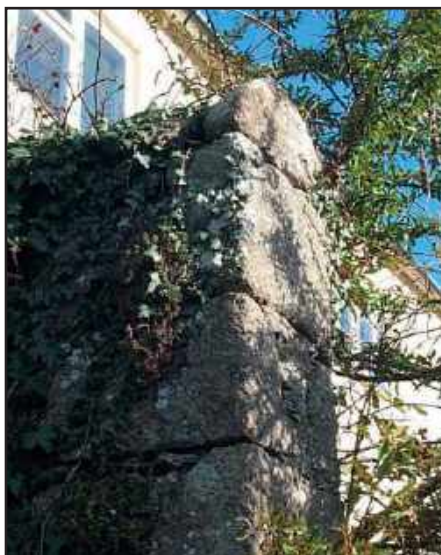
*Fig 27: Dressed granite wall at Old School Cottage*

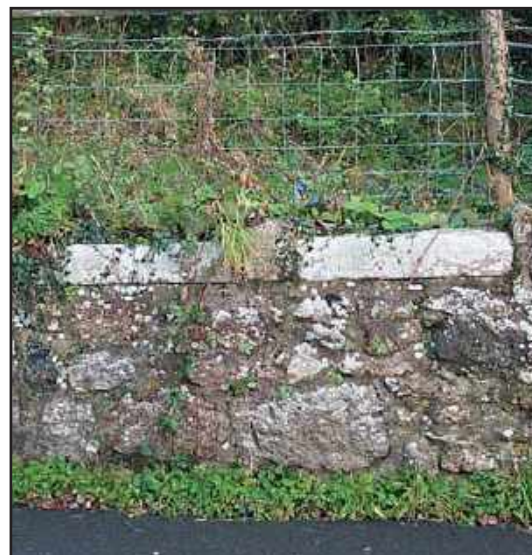
*Fig 28: Rubble wall with granite slab coping near Doone Cottage*

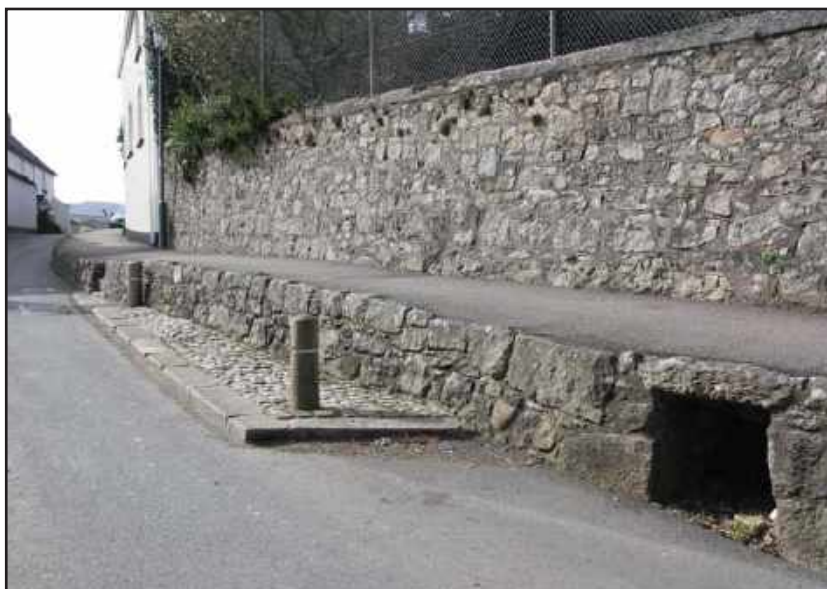
*Fig 29: Raised pavement and steps beside the school*

These are a feature of some villages and many towns in Devon and are usually an indication that the settlement enjoyed sufficient wealth and status to seek such enhancements. West of the church the pavement is almost continuous on the north side of the main street as far as the edge of the village beyond Townsend. At intervals there are granite steps linking to road level.

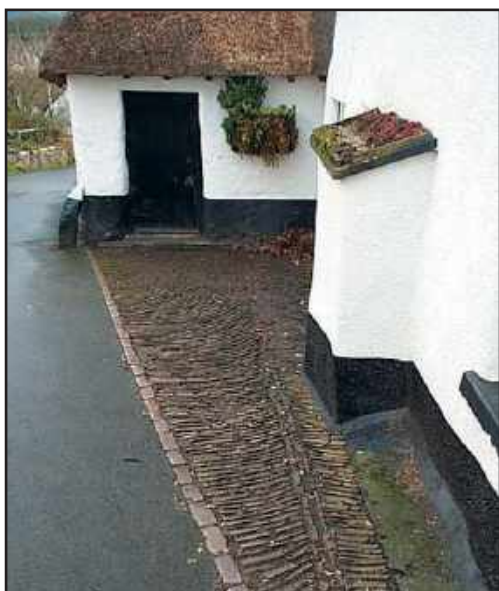
*Fig 30: The efficiently designed cobbling at Brimblecombes*

There are some outstanding examples of traditional cobbling in Dunsford. As well as the church path the areas in front of the Post Office and Brimblecombes are particularly fine. Other good examples include the patches at the bottom of the sets of church steps. Where pavements exist they are mostly edged with granite kerbs that offer a sense of quality and continuity to the streetscene.

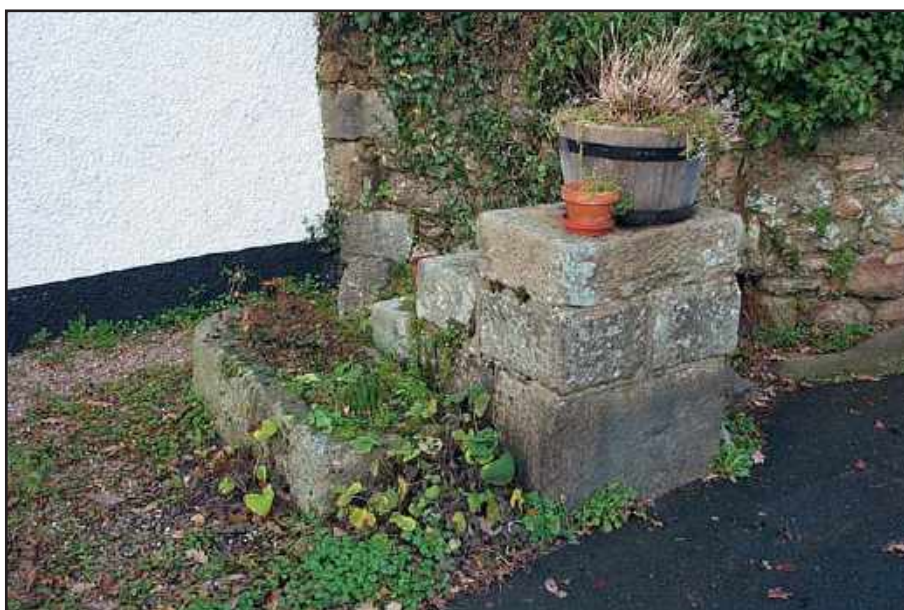
*Fig 32: Mounting block and granite trough at Foxhole*

There are two good mounting blocks in the centre of the village, outside the Old Post Office and Foxhole. These are in situ and are reminders of past times when horses were part of everyday life.

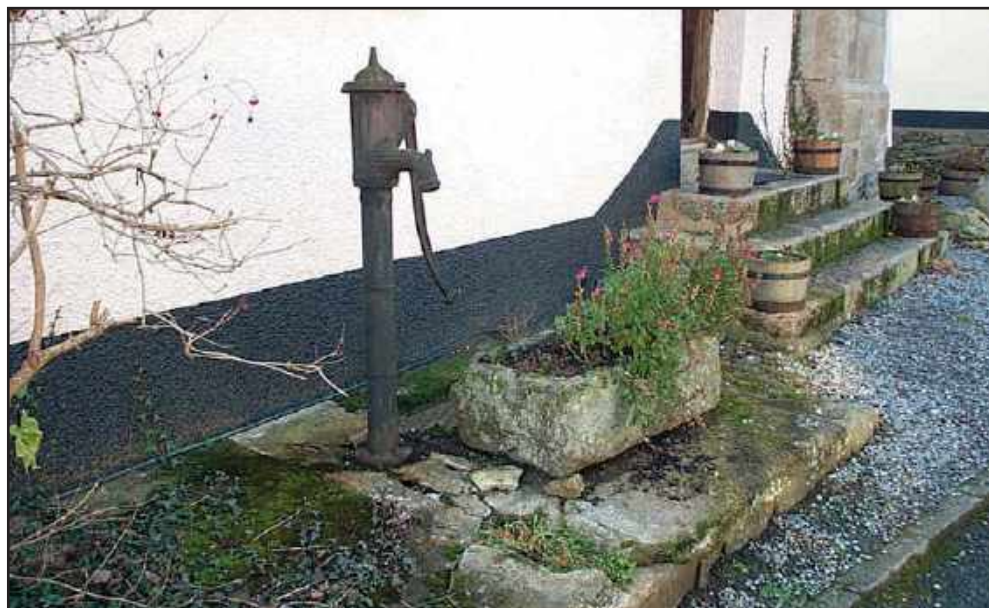
Fig 33: Pump, trough and steps at Old Cawte Farmhouse

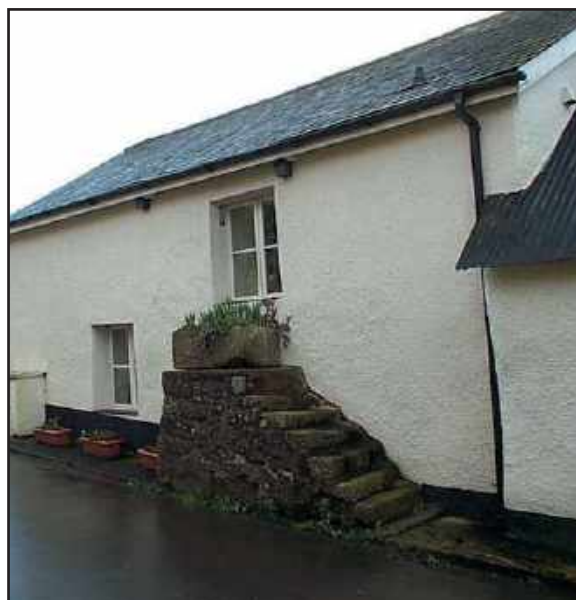
A variety of granite troughs are used as planters on roadside verges. In many cases this is presumably to deter vehicles as much as to add colour and interest. A significant number of properties have old granite steps that add to the richness of the streetscene. The grandest example is at Old Cawte Farmhouse, which also has a trough and pump adding to its setting. The more modest and purely functional steps, seen on a lot of other properties, are also important - a good example is at Poppy Cottage. The converted roadside barn called Felspar has an attractive external stair but the context is rather diluted by the modern window at the top replacing the doorway.

Fig 34: Barn steps at Felspar

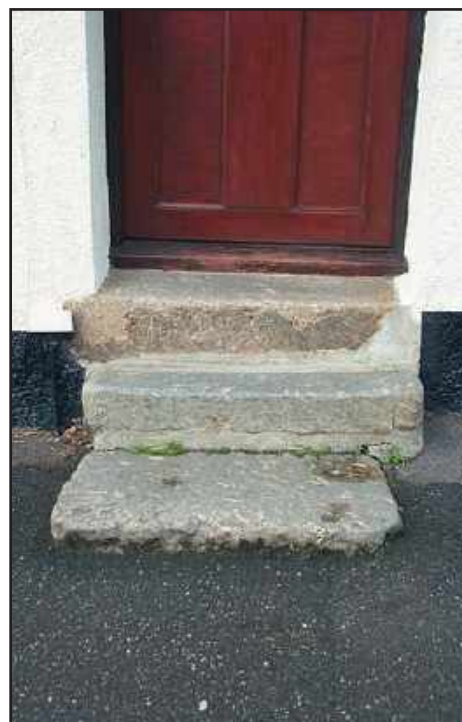
Fig 35: Steps at Poppy Cottage

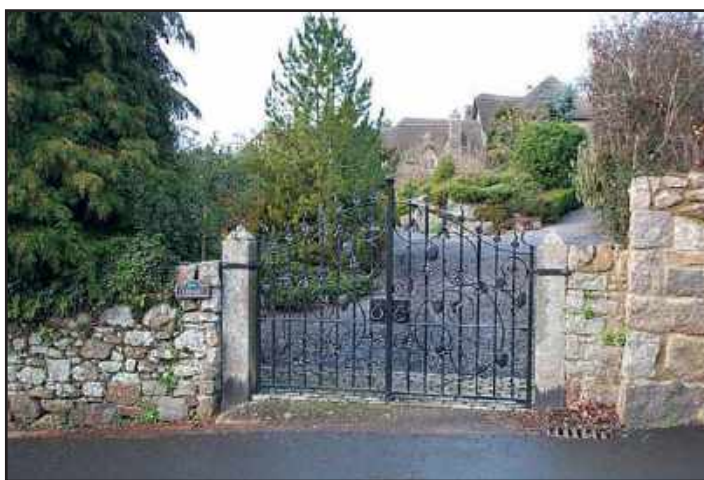
*Fig 37: The entrance to Lewishill*

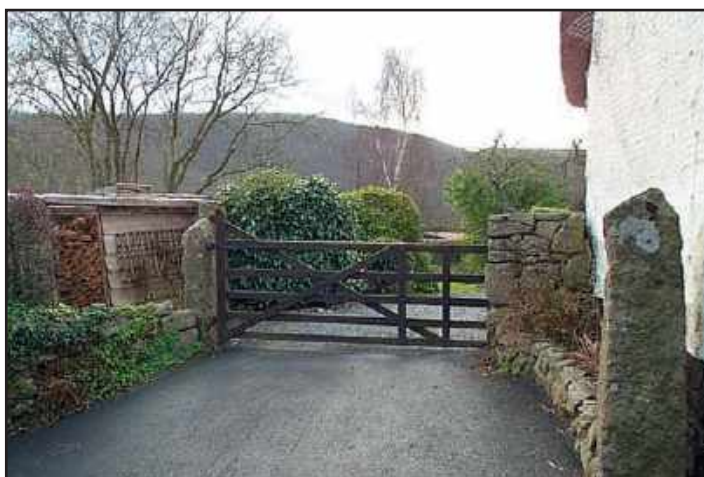
As there is a strong sense of enclosure in Dunsford, created by the tight building lines and the substantial boundary walls, gaps are all the more apparent. Fortunately many are framed by granite posts that range from the ancient to the carefully sculpted. Some granite posts have also been re-used as traffic deterrents. The cart entrance in the front elevation of East Steps is an interesting feature.

*Fig 38: Ancient gateposts re-used and in situ at Brimblecombes*
